THE TEST REPORT

A Newsletter of the California Council of Testing and Inspection Agencies

Fall 2008

CORROSIVE SOILS: CAUSES, EFFECTS, and MITIGATION

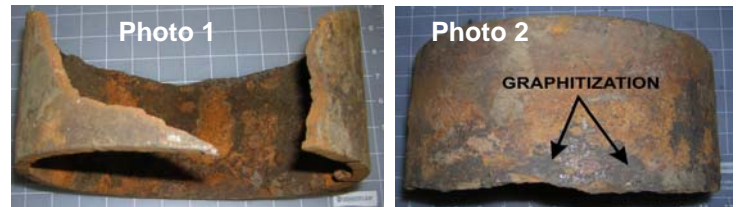
The pipe fragments were visually examined and photographed in our laboratory. Shown below are overall views of the interior and exterior of a typical section, photos 1 and 2, respectively. The dark patches on the exterior of the pipe represent a form of corrosion specific to cast iron known as graphitization. This will be discussed in more detail in the next section. The chemical composition and microstructure of the pipe material was analyzed and found to be consistent with cast iron with typical levels of porosity.

Photo 3 is a magnified view of the exterior of the pipe. This shows the extent of metal loss adjacent to the fracture surface. It is evident from the visual observations that the metal loss is confined to the exterior of the pipe, while the interior exhibited evidence of only mild to moderate corrosion.
